NUMI targets

Down until ~ Nov. 1 to replace target

A. E. M.
October 4, 2010
Jim Hylen/FNAL
Page 1

NT-04 failure

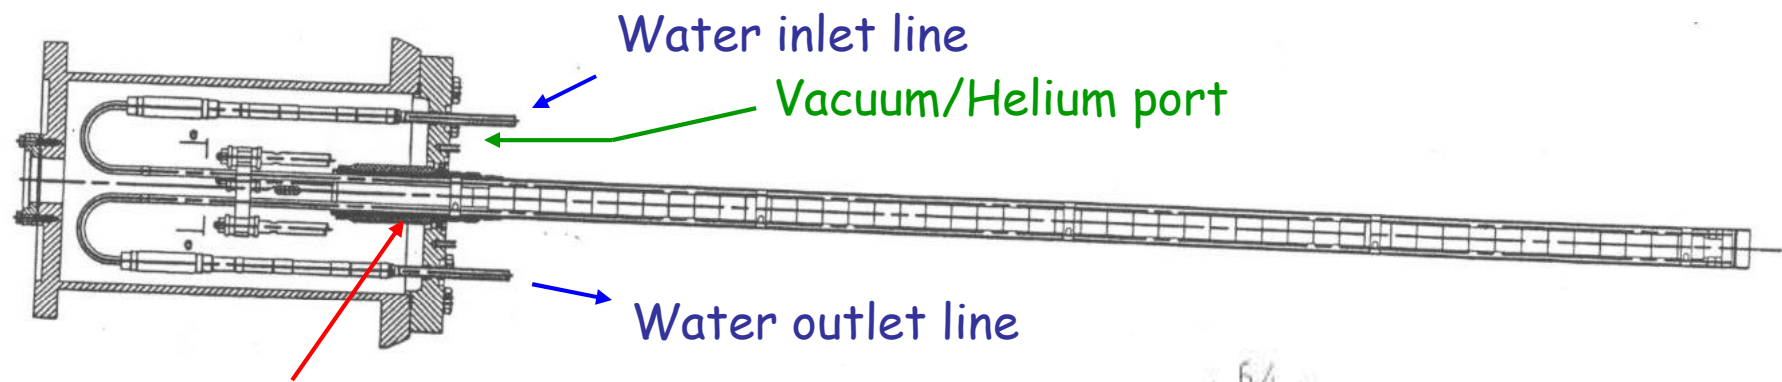
Ceramic electrical insulator

Exam showed leak at ceramic insulator at base of target - presumed cause is failure of braze joint or ceramic causing (X=4 mm, Y=8 mm) displacement of target tip

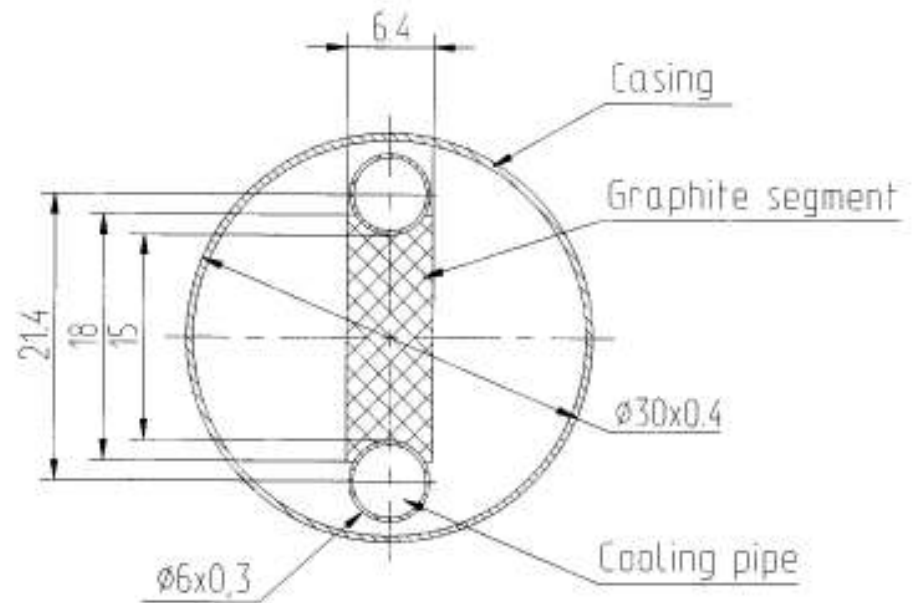
NT-04 target tip

See water drip, corrosion looks like left by water.

Target developed a small internal water leak to helium volume.
Amount of water was small enough to not be obvious during beam scans

Sept 9 21:40 pressure spike, knocking out upstream window,
and producing holes in downstream target tube - helium leak.
beam permit stops beam because of helium leak.

Water hammer on delicate welds of water lines likely failure point.

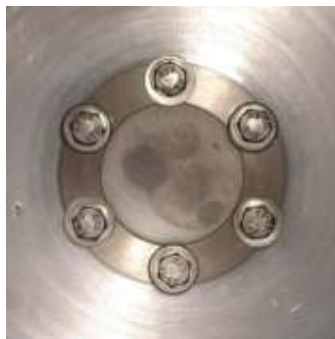
Most of Beryllium is on floor
of target pile , although

Beryllium window shard
resting on upstream baffle:

How big a pressure spike? ~ 100 psi to break window loose,
(about me stepping on window with my heel).
Note the 30 psi rupture disk at top of target pile did not rupture.
